# WOOD DESTROYING PESTS AND ORGANISMS INSPECTION REPORT

Building No. <b>115</b>	Street <b>N. Belle Ave Corona CA 92880</b>	City <b>Corona CA 92880</b>	Zip <b>92880</b>	Date of Inspection <b>06/07/18</b>	Number of Pages <b>8</b>
----------------------------	---	--------------------------------	---------------------	---------------------------------------	-----------------------------

REGISTRATION NO. <b>PR7257</b>	REPORT NO. <b>cr6115</b> Escrow#	
Ordered by: Keller Williams-Corona Ruben/Rocio 4160 Temescal Canyon Road Suite 500 92883-Corona-CA (951) 338-0241 (951) 432-8413	Property Owner and/or Party of Interest: Keller Williams-Corona 4160 Temescal Canyon Road Suite 500 92883-Corona-CA (951) 338-0241	Report sent to: Keller Williams-Corona 4160 Temescal Canyon Road Suite 500 92883-Corona-CA (951) 338-0241

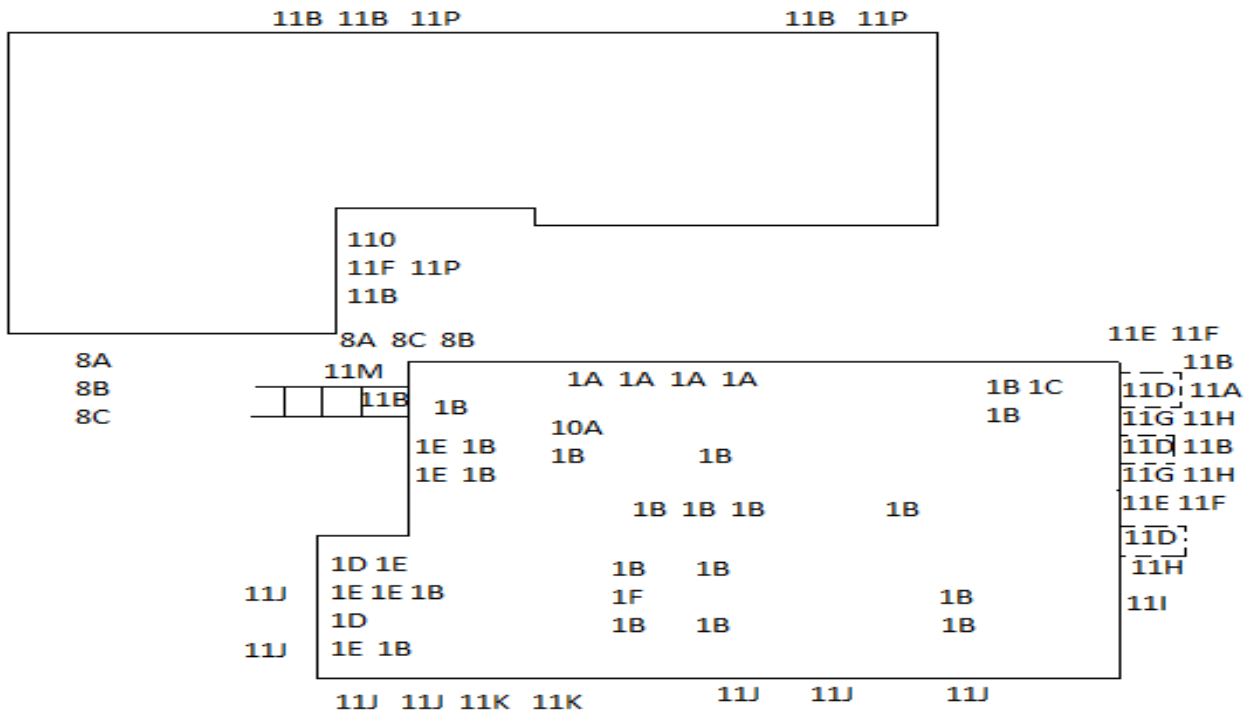
FOUNDATION DIAGRAM (Diagram not to scale)

Finding: 1A DRY ROT NOTED AT 1X6X4 SUB FLOOR AS INDICATED ON THE DIAGRAM.

Finding: 1C DRY ROT NOTED AT SUB FLOOR AS INDICATED ON THE DIAGRAM.

Finding: 1E EVIDENCE OF SUBTERRANEAN TERMITES NOTED IN THE SUB AREA AS INDICATED ON THE DIAGRAM.

Finding: 8A EVIDENCE OF DRYWOOD TERMITE DAMAGE NOTED AT DOOR JAMB AS INDICATED ON THE DIAGRAM.

Finding: 8B EVIDENCE OF DRYWOOD TERMITE DAMAGE NOTED AT STUCCO MOLDING AS INDICATED ON THE DIAGRAM.

Finding: 8C EVIDENCE OF DRYWOOD TERMITES NOTED AT DOOR JAMB, STUCCO MOLDING AS INDICATED ON THE DIAGRAM.

Finding: 10A DRY ROT NOTED AT 12X12 KITCHEN FLOOR AS INDICATED ON THE DIAGRAM.

Finding: 11A DRY ROT NOTED AT PLYWOOD IN WATER HEATER ROOM AS INDICATED ON THE DIAGRAM.

Finding: 11B DRY ROT NOTED AT PLYWOOD ROOF SHEATHING AS INDICATED ON THE DIAGRAM.

Finding: 11C DRY ROT NOTED AT 2X4X20 FASCIA AS INDICATED ON THE DIAGRAM.

Finding: 11D DRY ROT NOTED AT 2X4X2 RAFTER AS INDICATED ON THE DIAGRAM.

Finding: 11E EVIDENCE OF DRYWOOD TERMITE DAMAGE NOTED AT 2X4X4 FASCIA AS INDICATED ON THE DIAGRAM.

Finding: 11F EVIDENCE OF DRYWOOD TERMITES NOTED AT FASCIA,RAFTER AS INDICATED ON THE DIAGRAM.

Finding: 11G DRY ROT NOTED AT 1X8X16 SHEATHING AS INDICATED ON THE DIAGRAM.

Finding: 11H DRY ROT NOTED AT 2X4X6 RAFTERS AS INDICATED ON THE DIAGRAM.

Finding: 11I DRY ROT NOTED AT SIDE DOOR AS INDICATED ON THE DIAGRAM.

Finding: 11J DRY ROT NOTED AT 1X6X2 SHEATHING AS INDICATED ON THE DIAGRAM.

Finding: 11K DRY ROT NOTED AT 1X4X8 DOOR TRIM AS INDICATED ON THE DIAGRAM.

Finding: 11L DRY ROT NOTED AT 1X8X2 WOOD SIDING AS INDICATED ON THE DIAGRAM.

Finding: 11M DRY ROT NOTED AT 2X4X4 JOIST AS INDICATED ON THE DIAGRAM.

Finding: 11N FUNGUS NOTED AT ROOF SHEATHING AS INDICATED ON THE DIAGRAM.

Finding: 11O EVIDENCE OF DRYWOOD TERMITE DAMAGE NOTED AT 2X6X2 RAFTERS AS INDICATED ON THE DIAGRAM.

Finding: 11P DRY ROT NOTED AT 1X6X20 FASCIA AS INDICATED ON THE DIAGRAM.

Finding: 1B CELLULOSE DEBRIS NOTED IN SUBAREA AS INDICATED BY BA ON THE DIAGRAM

Finding: 1F EARTHWOOD CONTACTS NOTED AT PIER POST AS INDICATED ON THE DIAGRAM.

Recommendation: 1A **OWNER TO CONTACT PROPER TRADESMEN TO MAKE ANY NECESSARY REPAIRS.**

Recommendation: 1C **OWNER TO CONTACT PROPER TRADESMEN TO MAKE ANY NECESSARY REPAIRS.**

Recommendation: 1E **TRENCH AND TREAT SUBAREA SOIL WITH REGISTERED CHEMICAL-FOR THE CONTROL OF SUBTERRANEAN TERMITES.REMOVE ALL ACCESSIBLE SUBTERRANEAN TERMITE TUBING.**

Recommendation: 8A **OWNER TO CONTACT PROPER TRADESMEN TO MAKE ANY NECESSARY REPAIRS.**

Recommendation: 8B **OWNER TO CONTACT PROPER TRADESMEN TO MAKE ANY NECESSARY REPAIRS.**

Recommendation: 8C **THIS IS A PRIMARY RECOMMENDATION-VACATE PREMISES AND SEAL THE STRUCTURE. FUMIGATE WITH A LETHAL GAS-OVERNIGHT.REMOVE THE SEALS AND AIR BUILDING READY FOR OCCUPANCY.REMOVE OR COVER ACCESSIBLE EVIDENCE OF INFESTATION.**

Recommendation: 10A **OWNER TO CONTACT PROPER TRADESMEN TO MAKE ANY NECESSARY REPAIRS.**

Recommendation: 11A **OWNER TO CONTACT PROPER TRADESMEN TO MAKE ANY NECESSARY REPAIRS.**

Recommendation: 11B **OWNER TO CONTACT PROPER TRADESMEN TO MAKE ANY NECESSARY REPAIRS.**

Recommendation: 11C **OWNER TO CONTACT PROPER TRADESMEN TO MAKE ANY NECESSARY REPAIRS.**

Recommendation: 11D **OWNER TO CONTACT PROPER TRADESMEN TO MAKE ANY NECESSARY REPAIRS.**

Recommendation: 11E **OWNER TO CONTACT PROPER TRADESMEN TO MAKE ANY NECESSARY REPAIRS.**

Recommendation: 11F **THIS IS A PRIMARY RECOMMENDATION-VACATE PREMISES AND SEAL THE STRUCTURE. FUMIGATE WITH A LETHAL GAS-OVERNIGHT.REMOVE THE SEALS AND AIR BUILDING READY FOR OCCUPANCY.REMOVE OR COVER ACCESSIBLE EVIDENCE OF INFESTATION.**

Recommendation: 11G **OWNER TO CONTACT PROPER TRADESMEN TO MAKE ANY NECESSARY REPAIRS.**

Recommendation: 11H **OWNER TO CONTACT PROPER TRADESMEN TO MAKE ANY NECESSARY REPAIRS.**

Recommendation: 11I **OWNER TO CONTACT PROPER TRADESMEN TO MAKE ANY NECESSARY REPAIRS.**

Recommendation: 11J **OWNER TO CONTACT PROPER TRADESMEN TO MAKE ANY NECESSARY REPAIRS.**

Recommendation: 11K **OWNER TO CONTACT PROPER TRADESMEN TO MAKE ANY NECESSARY REPAIRS.**

Recommendation: 11L **OWNER TO CONTACT PROPER TRADESMEN TO MAKE ANY NECESSARY REPAIRS.**

Recommendation: 11M **OWNER TO CONTACT PROPER TRADESMEN TO MAKE ANY NECESSARY REPAIRS.**

Recommendation: 11N **WIRE BRUSH AND REMOVE ALL VISIBLE AND ACCESSIBLE SURFACE FUNGUS. TREAT THE INFECTED AND ADJACENT WOOD MEMBERS WITH TIMBOR (ACTIVE INGREDIENT, SODIUM OCOBORATE) TO CONTROL THE WOOD DECAY FUNGI.**

Recommendation: 11O **OWNER TO CONTACT PROPER TRADESMEN TO MAKE ANY NECESSARY REPAIRS.**

Recommendation: 11P **OWNER TO CONTACT PROPER TRADESMEN TO MAKE ANY NECESSARY REPAIRS.**

Recommendation: 1B **REMOVE CELLULOSE DEBRIS AND TAKE AWAY FROM THE PREMISES.**

Recommendation: 1F **OWNER TO CONTACT PROPER TRADESMEN TO MAKE ANY NECESSARY REPAIRS.**
