ELITE GROUP

1133 Circle City Dr, Corona, CA 92879
Inspection prepared for: Frank Silva
Date of Inspection: 11/5/2019 Time: 9:00 AM
Age of Home: 1947 Size: 858
Weather: Clear, 65 degrees, Dry
Order ID: 191101

Summary Page

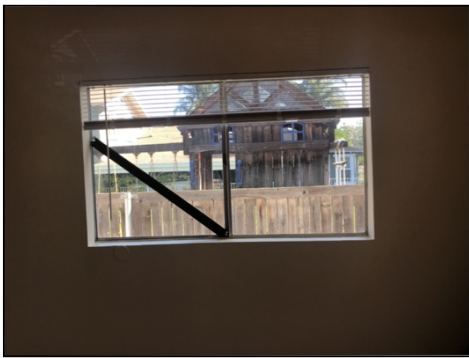
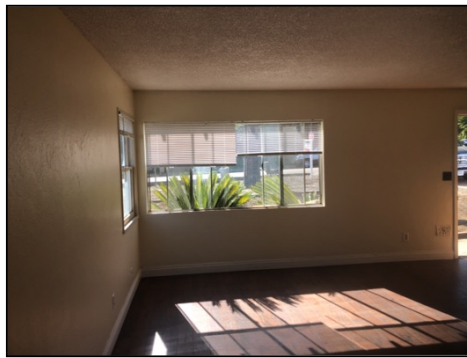
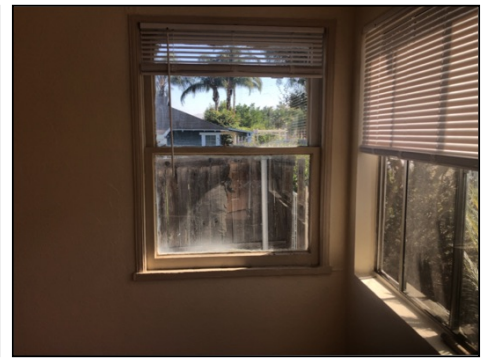
4. Window Conditions

Accessible windows were tested and operated at time of inspection • Visible/accessible windows have worn frames/hardware/sills/tracks - typical for age • Recommend general window maintenance/lubrication and weather tight service • Stuck in position - needs to be serviced

Stuck in position - needs to be serviced

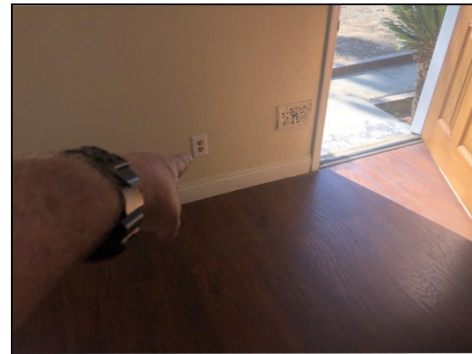
A representative number of receptacles and switches were tested and found to be operational at time of inspection • Outlets/switches had normal wear for age - no major visible defects • Outlets painted over - needs to be serviced • **Three prong outlet(s) not grounded - needs to be serviced** • **Non-energized (dead) outlet(s) - needs to be serviced**

Non-energized (dead) outlet(s) - needs to be serviced

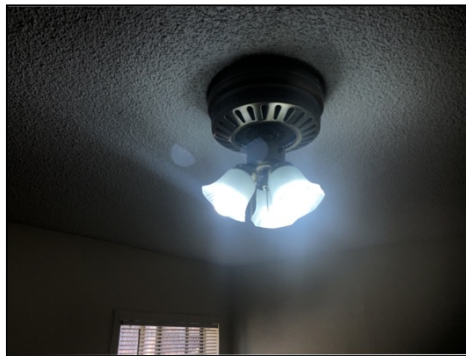
Normal wear for age, no major visible defects • Missing fan blades - needs to be serviced • Note: It is not possible to determine the method of attachment to the ceiling. These units are heavy and due to the designed movement, must have the proper style mounting boxes for correct and safe attachment. Recommend confirming the method of attachment prior to use. This may require the removal of the fan or insulation to visually verify proper support.

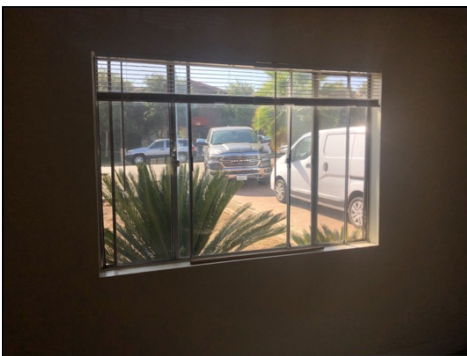
6. Window Conditions

Accessible windows were tested and operated at time of inspection • Visible/accessible windows have worn frames/hardware/sills/tracks - typical for age • Recommend general window maintenance/lubrication and weather tight service • Difficult to operate or slide - needs to be serviced

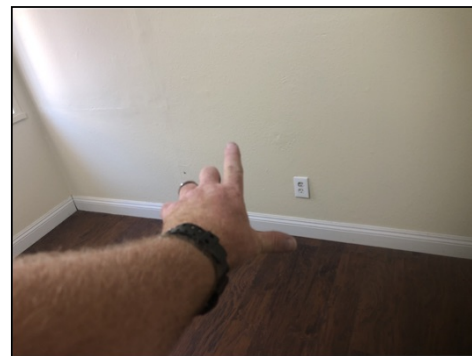
Non-energized (dead) outlet(s) - needs to be serviced

Loose outlets - needs to be serviced - north

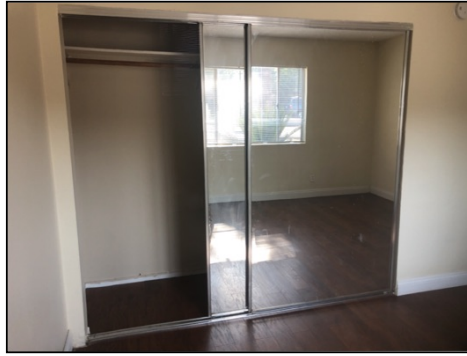
Bypass doors difficult to operate - needs to be serviced

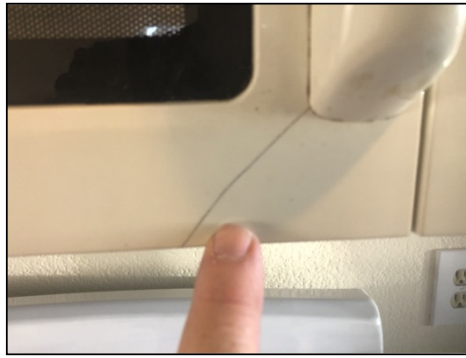
15. Microwaves

The microwave is tested with a microwave tester or damp sponge/cloth only. No other features of the microwave are tested or evaluated for cooking. The home inspector cannot predict the remaining life left in the unit. • Tested and operational at time of inspection via normal controls • Worn/older unit - typical wear for age and use • Visible cracks in door/frame - needs to be serviced

Visible cracks in door/frame - needs to be serviced

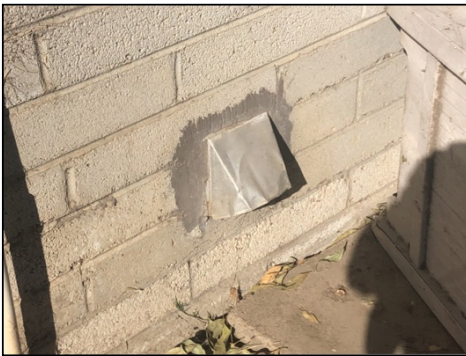
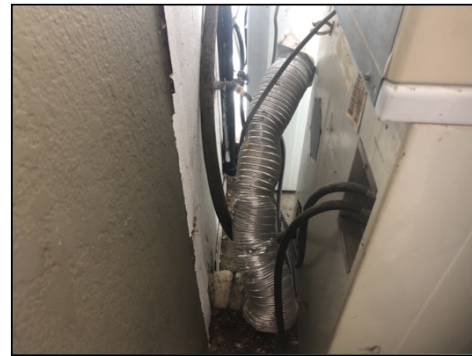
Dryer vent should be cleaned periodically to prevent lint fire hazards • Could not fully inspect the dryer vent in the laundry area, it is obscured by cabinetry/washer/dryer • Damaged/bent exterior cover - recommend replacement/upgrade

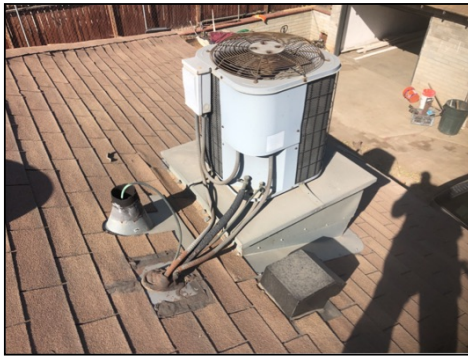
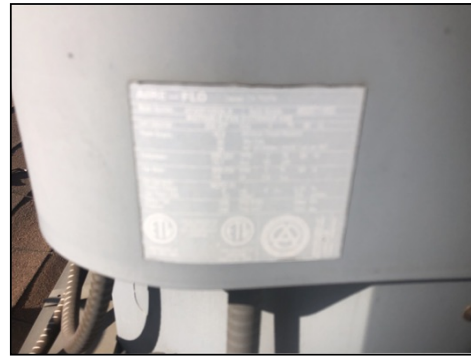
13. Air Conditioning Compressors

Visible areas of unit are worn and weathered – recommend seasonal service and maintenance to extend the life of the unit • Unit did not operate or respond to thermostat commands - needs to be serviced/further evaluated

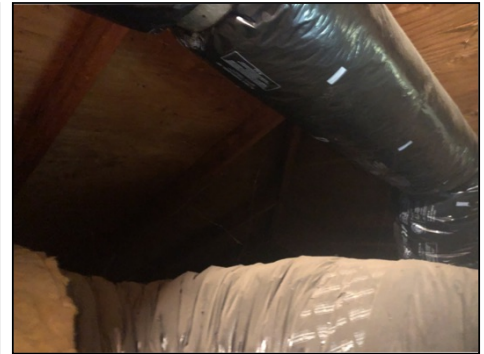
Framing has been altered or modified and is not original to the structure - check all building permits to ensure that all framing was installed to code • Conventional framing present, normal wear at time of inspection - no major visible defects • Consult termite report for all wood areas in the attic • No major visible staining found at the time of the inspection • Limited attic inspection - many areas are not accessible to to limited space, lack of proper walk boards, electrical, plumbing, ductwork, etc. • Charred wood observed - consult with seller

Charred wood observed - consult with seller

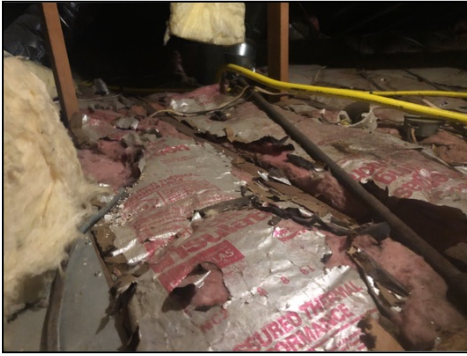
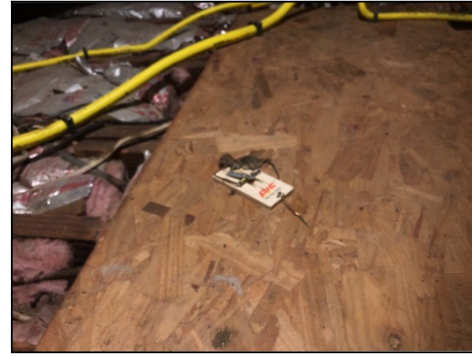
All visible insulation is worn/older/dirty - typical for the age of the structure • Damaged - needs to be serviced • The inspector does not determine R-value of the insulation • Insulation generally blocks visible inspection access to framing below level of insulation • Limited access/access hindrances prevent visible inspection of areas of insulation • **Evidence of rodent/bird/pest activity in the attic**

Evidence of rodent/bird/pest activity in the attic

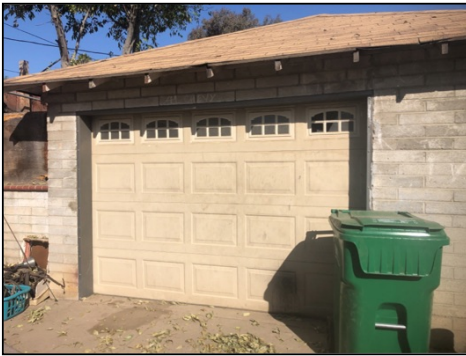
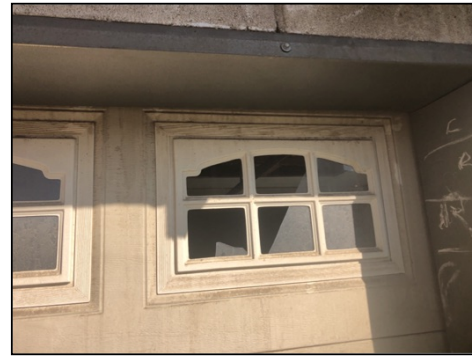
3. Main Automotive Doors

Worn/weathered door - typical for age and exposure to weather • Recommend weather tight service/maintenance to prevent moisture intrusion around main door areas • **Cracked/missing/damaged glass window - needs to be serviced**

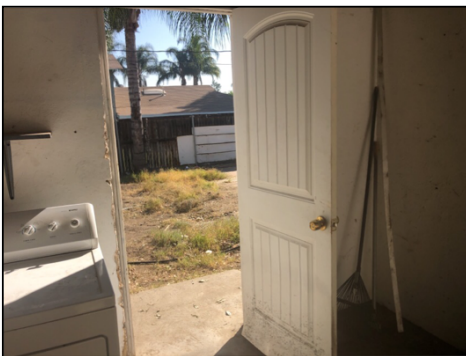
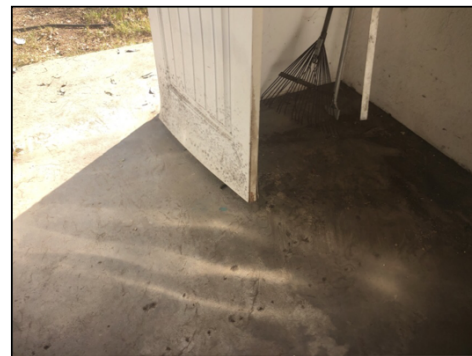
Operated at the time of inspection • Worn/weathered door - typical for age • Recommend weather tight service/maintenance to prevent moisture intrusion • Delaminated at bottom - needs to be serviced • Hollow core interior door present - recommend replacement with exterior rated door • Missing proper weather stripping/seals at exterior door - needs to be serviced

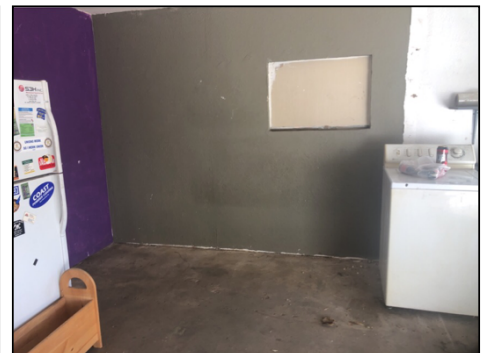
Small cracks/holes/chipped/dirty areas/cosmetic blemishes observed - typical for age of structure • Personal items/storage/etc. are present and prevent a complete inspection of wall areas • Irregular staining present

Irregular staining present

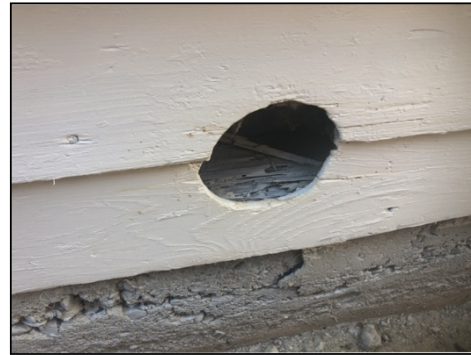
Small cracking/chipping/holes present - recommend siding service/maintenance and sealing all holes and gaps

Cracking/chipping/holes more than typical - needs to be serviced

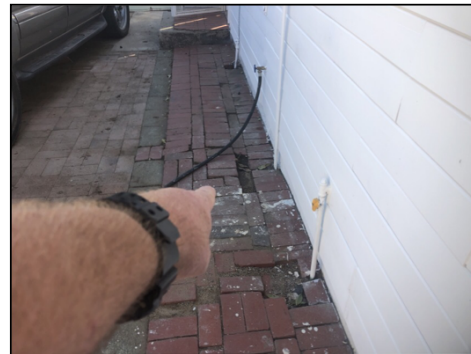
- Personal items present - some areas not visible for inspection
- **Displaced/lifted/uneven areas trip hazard - needs to be serviced**

Displaced/lifted/uneven areas trip hazard - needs to be serviced

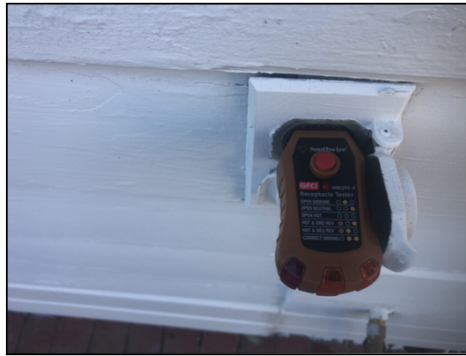
Non- energized (dead) outlet(s) - needs to be serviced

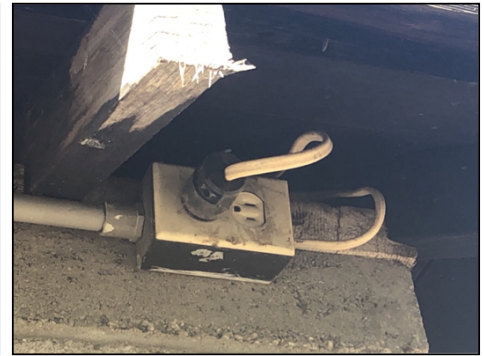
Exterior outlet/switch covers are missing or not of proper exterior weather proof type - needs to be serviced

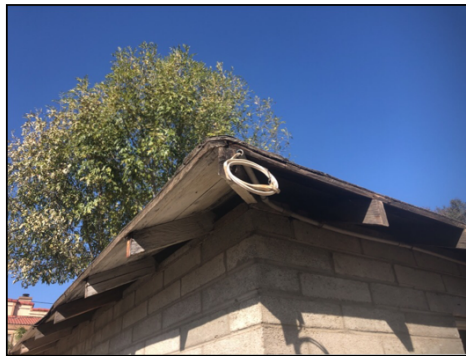
Exposed wires/connections - potential hazard - needs to be serviced
