INSPECTION PROFESSIONALS

14480 Laurel Dr, Riverside, CA 92503
Inspection prepared for: Mark Kehl
Real Estate Agent: Ruben Muro - Keller Williams (Corona)

Date of Inspection: 2/9/2018 Time: 3:00 PM
Age of Home: 1984 Size: 1846
Weather: Sunny
Order ID: 133734

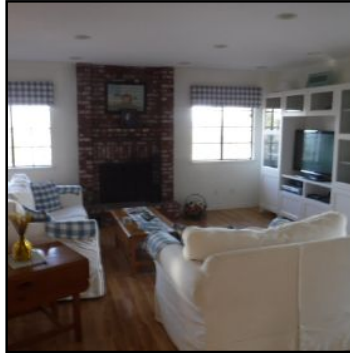
INTERIOR Wall Conditions

Small cracks/holes/chipped/dirty areas/cosmetic blemishes observed - typical for age of structure

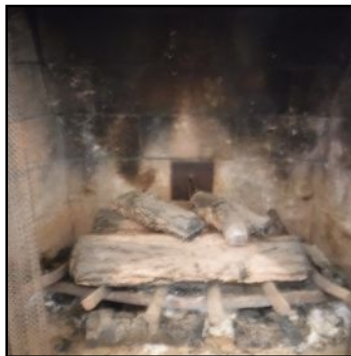
INTERIOR Fireplaces

Location/s: Living room
 Mason built
 Damper was worn/rusted/dirty - recommend cleaning • Gas log lighter present

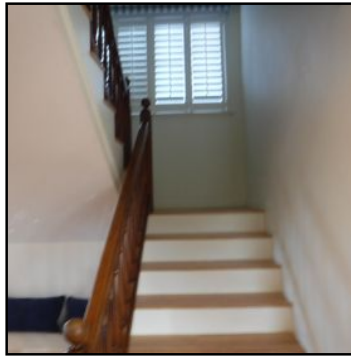
INTERIOR Stairs & Handrails

Loose rails - needs to be serviced for optimum safety

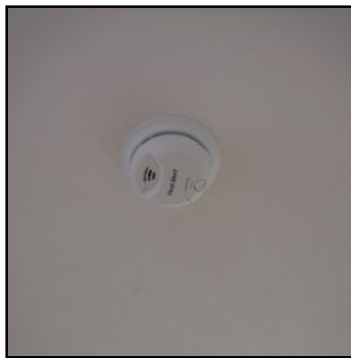
INTERIOR Smoke Detectors

INSP	NINSP	NFE	NONE	
<input checked="" type="checkbox"/>	<input type="checkbox"/>	<input type="checkbox"/>	<input type="checkbox"/>	Operational at time of inspection via factory installed test button

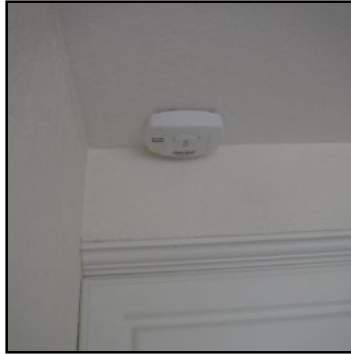
INTERIOR Carbon Monoxide Detectors

INSP	NINSP	NFE	NONE	
<input checked="" type="checkbox"/>	<input type="checkbox"/>	<input type="checkbox"/>	<input type="checkbox"/>	Operational at time of inspection via factory installed test button

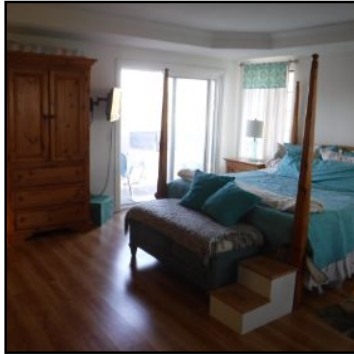
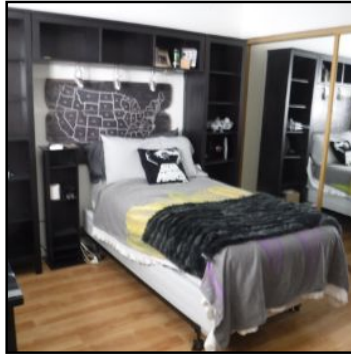
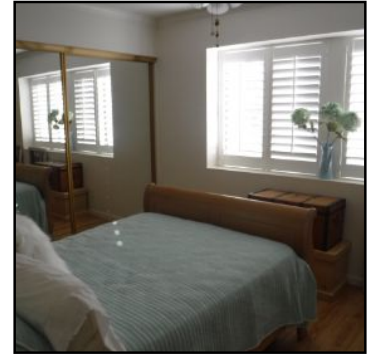
Small cracks/holes/chipped/dirty areas/cosmetic blemishes observed - typical for age of structure

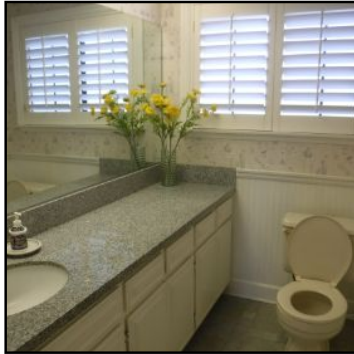
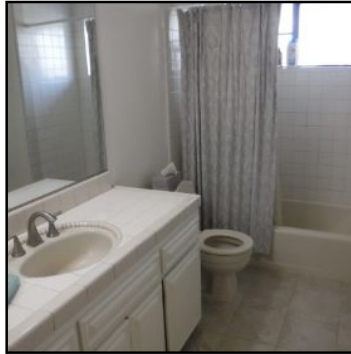
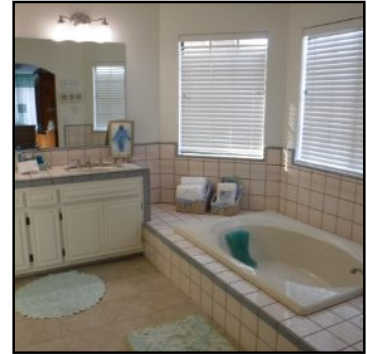
Small cracks/holes/chipped/dirty areas/cosmetic blemishes observed - typical for age of structure

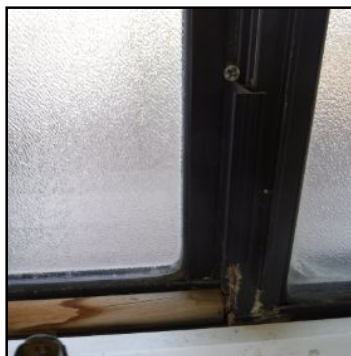
BATHROOMS Window Conditions

Accessible windows were tested and operated at time of inspection • Visible/accessible windows have worn frames/hardware/sills/tracks - typical for age • **Stuck in position - needs to be serviced-downstairs**

BATHROOMS		
Page 11 Item: 5	Window Conditions	• Stuck in position - needs to be serviced-downstairs
Page 13 Item: 15	Shower Walls	• Cracked materials - needs to be serviced/repaired-hall
KITCHEN		
Page 17 Item: 21	Dishwashers	• Drains directly to the disposal without an air gap - improper installation - needs to be serviced
LAUNDRY AREA		
Page 20 Item: 15	Electrical	• 240v service is not energized- needs to be serviced
HEATING/AIR CONDITIONING		
Page 21 Item: 1	Heaters	• Premier heater present - possible recall - recommend licensed heating contractor or gas company to evaluate this unit (includes all possible re-branded units) • https://www.cpsc.gov/Recalls/2001/CPSC-Announces-Recall-of-Furnaces-in-California/
WATER HEATERS		
Page 25 Item: 6	Overflow Line/s	• None - needs to be serviced/installed
ELECTRICAL/GAS SERVICE		
Page 26 Item: 3	Panel Wiring	• Unused wires present - consult electrician to trace wires/evaluate as needed

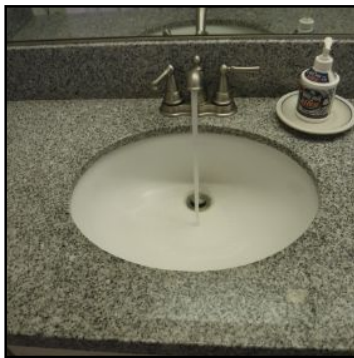
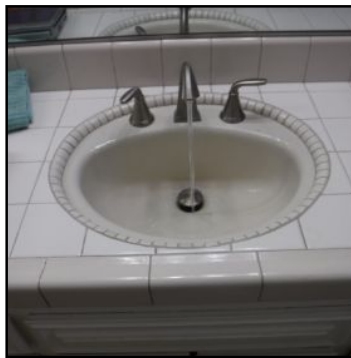
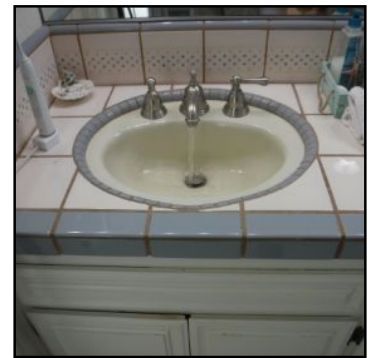
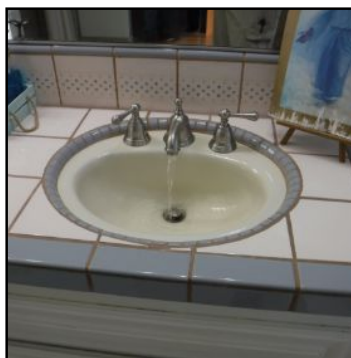
Fixture operated at the time of the inspection

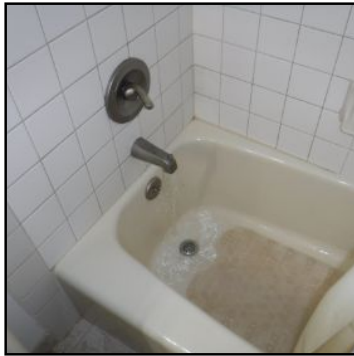
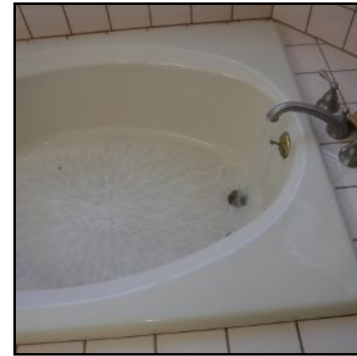
Fixture was tested and operating at the time of the inspection

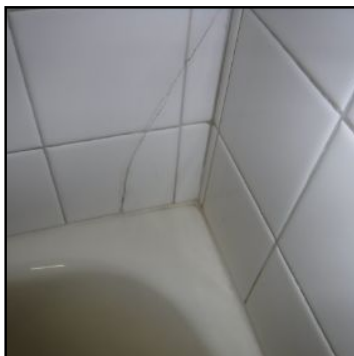
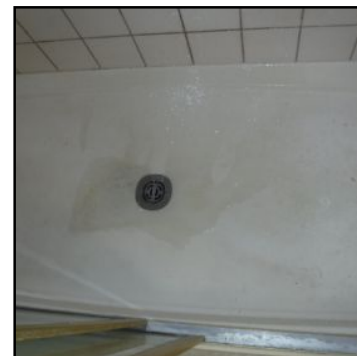
Wall materials in a worn/stained-faded/old condition - typical for age - recommend routine grout and sealer maintenance • Shower pan is in a worn/stained/older condition - typical for the age - recommend routine grout and sealer maintenance • **Cracked materials - needs to be serviced/repaired-hall**

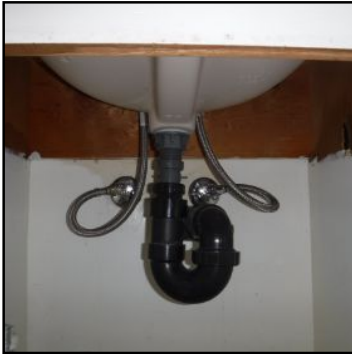
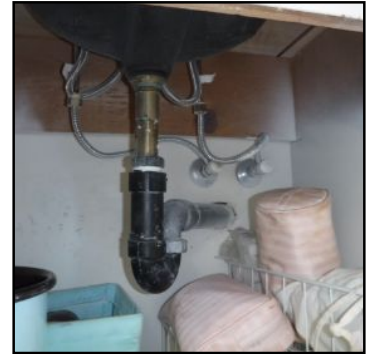
INSP	NINSP	NFE	NONE	Operational at time of inspection via normal fixture controls with no major visible defects
<input checked="" type="checkbox"/>	<input type="checkbox"/>	<input type="checkbox"/>	<input type="checkbox"/>

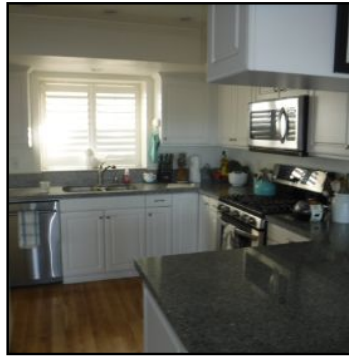
KITCHEN Wall Conditions

Small cracks/holes/chipped/dirty areas/cosmetic blemishes observed - typical for age of structure

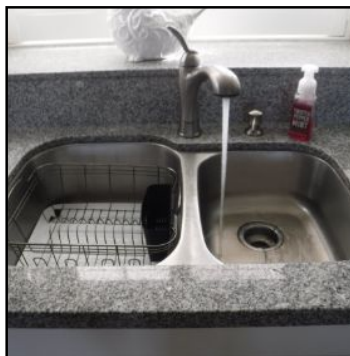
KITCHEN Sinks

Fixture operated at the time of the inspection

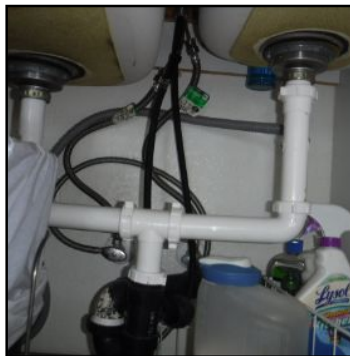
KITCHEN Plumbing

Operational at time of inspection via normal fixture controls with no major visible defects

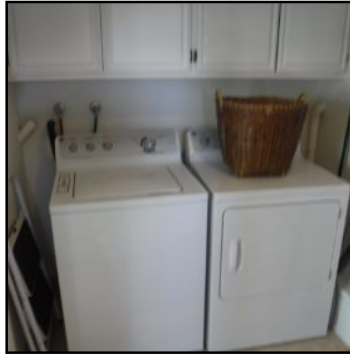
LAUNDRY AREA Wall Conditions

Small cracks/holes/chipped/dirty areas/cosmetic blemishes observed - typical for age of structure

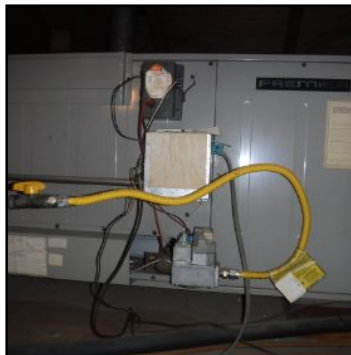
HEATING/AIR CONDITIONING Heaters

Operated at time of inspection • Visible areas of unit are worn and older - we recommend that you budget for a replacement and more efficient unit - recommend seasonal service and maintenance to extend the life of the unit • **Premier heater present - possible recall - recommend licensed heating contractor or gas company to evaluate this unit (includes all possible re-branded units) •**

<https://www.cpsc.gov/Recalls/2001/CPSC-Announces-Recall-of-Furnaces-in-California/>

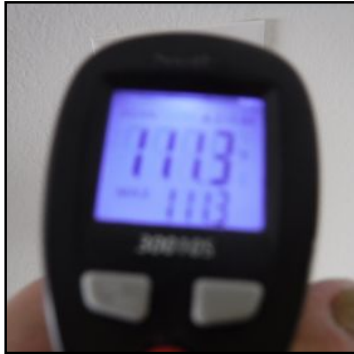
Heater Temperature at Registers: 100 degrees • **A/C** Temperature at Registers:60 degrees • Temperature at Air Return:80 degrees

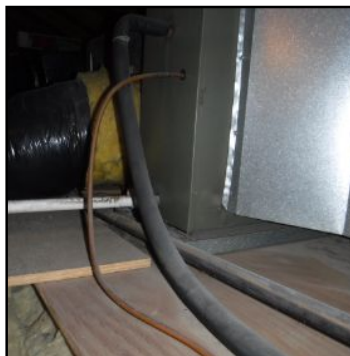
HEATING/AIR CONDITIONING Refrigerant Lines

Normal wear day of the inspection - no major visible defects - recommend annual/seasonal maintenance to check and service insulation on refrigerant lines as needed

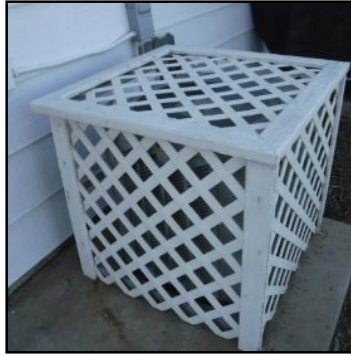
HEATING/AIR CONDITIONING Air Conditioning Compressors

Location: Electric unit - exterior south
Operated at the time of inspection

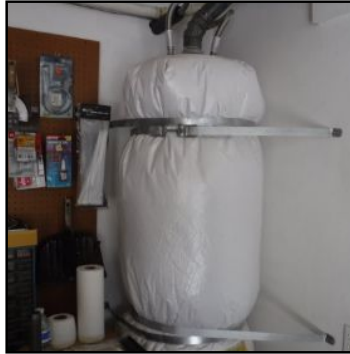
WATER HEATERS Water Heaters Condition

Number of gallons: Blanket present gallons not visible - the blanket prevents a complete inspection of this unit - limited view of most areas
Operated at the time of the inspection

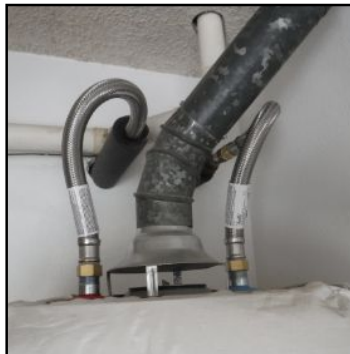
WATER HEATERS Plumbing

Material type: Copper • Insulated lines - plumbing is not fully visible
Normal wear at time of inspection - no major visible defects or leaks found at the time of the inspection

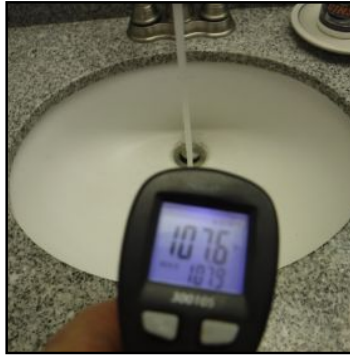
WATER HEATERS Water Heater Temperature

100 F

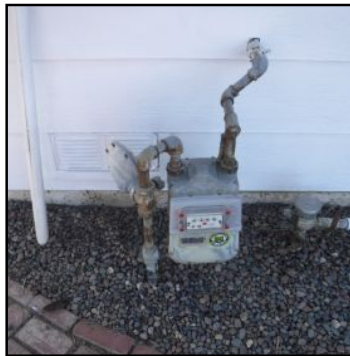
ELECTRICAL/GAS SERVICE Main Gas Valve

- Valve has normal wear for age at the time of inspection - no major visible defects
- No seismic safety valve present - recommend installation for increased safety

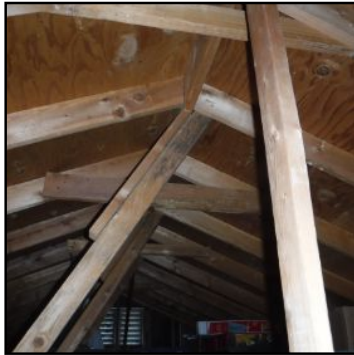
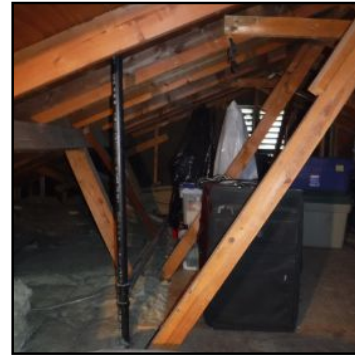
Conventional framing functional, normal wear at time of inspection - no major visible defects

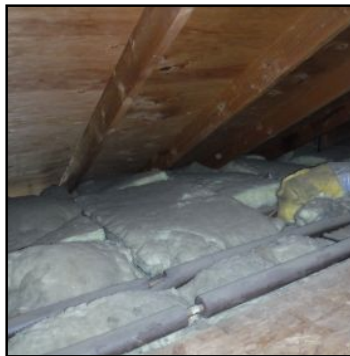
ATTIC AREA Insulation

Approximate depth: 4-6 inches in depth - more recommended
All visible insulation is worn/older/dirty - typical for the age of the structure

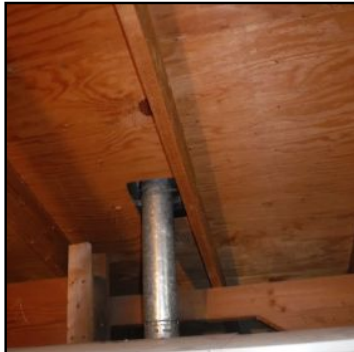
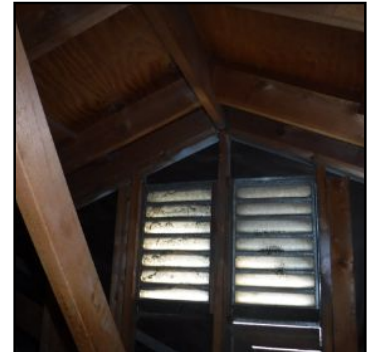
Some vents are not visible or accessible and cannot be inspected - N/A • All visible vents appear to be in normal condition where visible - no major visible defects

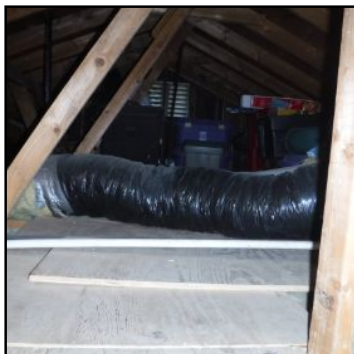
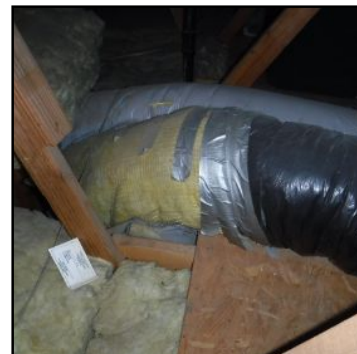
Older/worn ducts present - recommend routine maintenance and cleaning to extend the life of the existing ducts • Outer wrap damaged minor - needs to be serviced

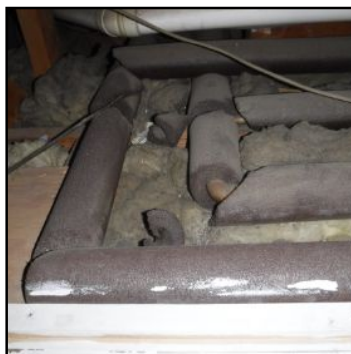
ATTIC AREA Plumbing

Evidence of altered plumbing/piping in the attic - check all installation permits to ensure that all plumbing was installed to city/county building code • Visible piping areas appeared to be in normal condition for age - no major visible defects at the time of the inspection

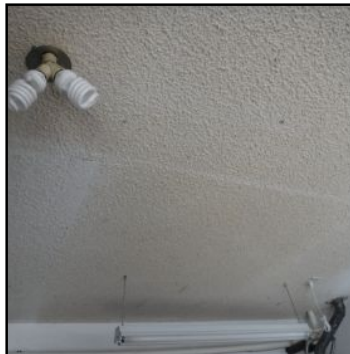
GARAGE AND/OR CARPORT Rafters & Ceilings

INSP	NINSP	NFE	NONE	
<input checked="" type="checkbox"/>	<input type="checkbox"/>	<input type="checkbox"/>	<input type="checkbox"/>	Drywall present – no visible access to view rafters • Patched areas observed - inquire with seller regarding reason for repairs

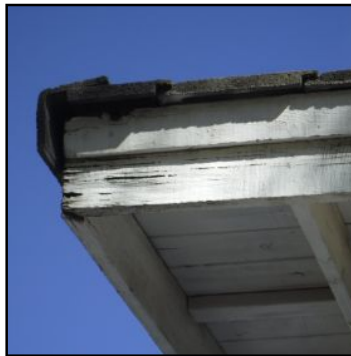
EXTERIOR AREAS Eaves & Fascia

Weathering and staining present in areas • **Deteriorated in areas - needs to be serviced - consult the termite report**

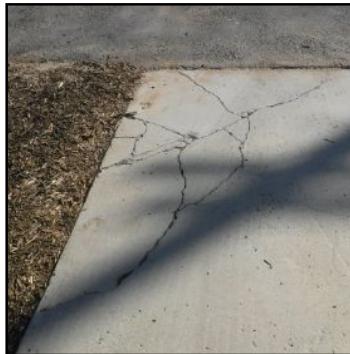
GROUNDS Driveways and Walkways

Constructed of: Concrete • Brick

Worn with common cracks/chips - typical for age of material

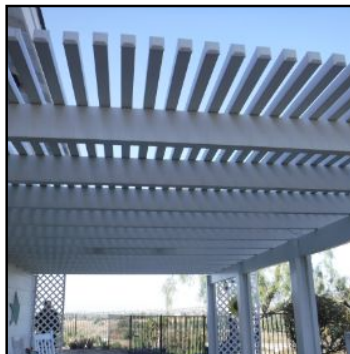
GROUNDS Patio and Porch Roofs

Constructed of: Shade type plastic

Worn/weathered materials - typical for age

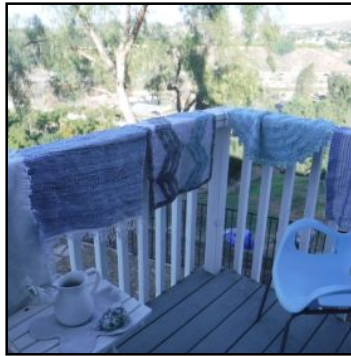
GROUNDS Balcony and Deck Railing

Wood railings present - consult termite report for all exterior wood • Normal wear on the day of the inspection - no major visible defects

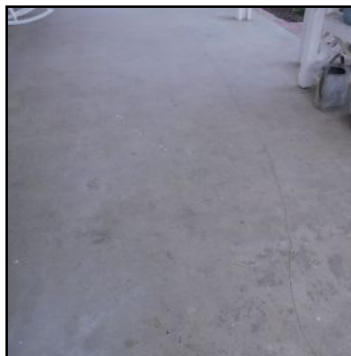
GROUNDS Patio and Porch Decks

Worn with common cracks/chips - typical for age of material

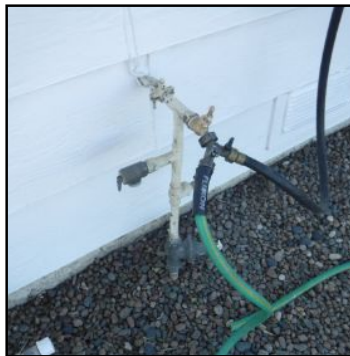
GROUNDS Main Water Valve

- Gate valve present/worn - consider upgrading to a ball valve

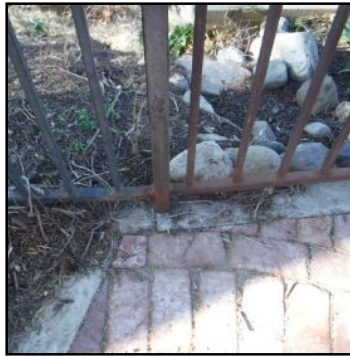
GROUPS Fencing and Walls

- Visible fencing/wall areas are worn and weathered - typical for the age of the materials •
- Rust/rust damage at metal fence materials - needs to be serviced

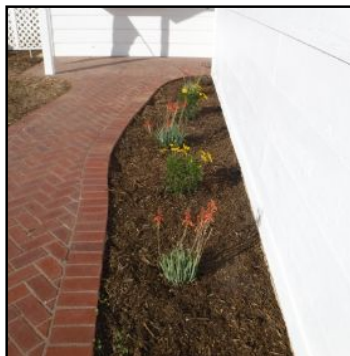
GROUPS Planters

No drain(s) visible for planter, recommend confirm or installation - needs to be serviced

GARAGE AND/OR CARPORT		
Page 32 Item: 9	Fire Doors	• Door is not a fire rated - needs to be replaced with a fire rated door
Page 33 Item: 20	Ventilation	• Vents obstructed by personal items/cabinets - needs to be serviced
EXTERIOR AREAS		
Page 34 Item: 6	Eaves & Fascia	• Deteriorated in areas - needs to be serviced - consult the termite report
GROUNDS		
Page 38 Item: 10	Exterior Plumbing and Faucets	• Bibb(s) not functional at one or more locations - needs to be serviced
Page 39 Item: 12	Water Pressure	• Pressure is higher than 120 psi, we recommend that a plumber further evaluate this high pressure as soon as possible
Page 39 Item: 13	Pressure Regulator	• Installed but pressure is above 80 PSI - needs to be serviced by a plumbing contractor
Page 39 Item: 15	Fencing and Walls	• Rust/rust damage at metal fence materials - needs to be serviced
Page 40 Item: 17	Planters	• No drain(s) visible for planter, recommend confirm or installation - needs to be serviced

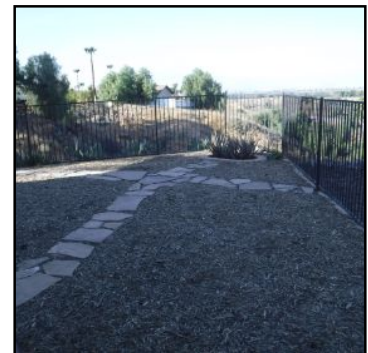
No drains visible at the property at the time of the inspection, drains are recommended to divert water away from structure

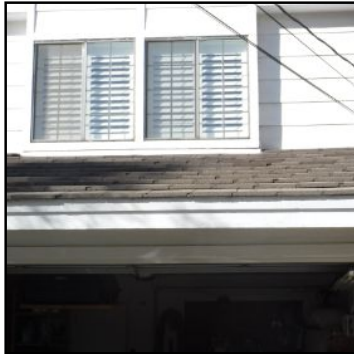
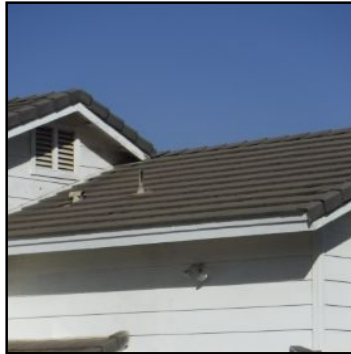
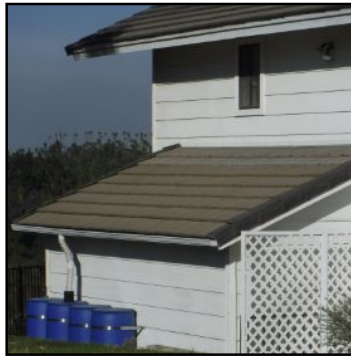
Worn and weathered materials present - typical for age and weather exposure - roof needs maintenance • **Loose/slipping tiles/shingles - needs to be serviced**

ROOF		
Page 41 Item: 1	Condition	• Loose/slipping tiles/shingles - needs to be serviced
Page 42 Item: 6	Spark Arrestors	• No spark arrestor/rain cap present - recommend installation

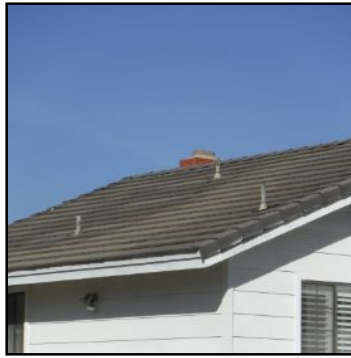
ROOF Vents and Vent Caps

Worn/weathered cap(s) – recommend seasonal maintenance to ensure that caps do not become loose or develop other defects
