WOOD DESTROYING PESTS AND ORGANISMS INSPECTION REPORT

Building No. 758	Street Beverly Rd. Corona CA 92879	City Corona CA 92879	Zip 92879	Date of Inspection 02/07/19	Number of Pages 5
----------------------------	----------------------------------------------	--------------------------------	---------------------	---------------------------------------	-----------------------------

REPORT# ja4765

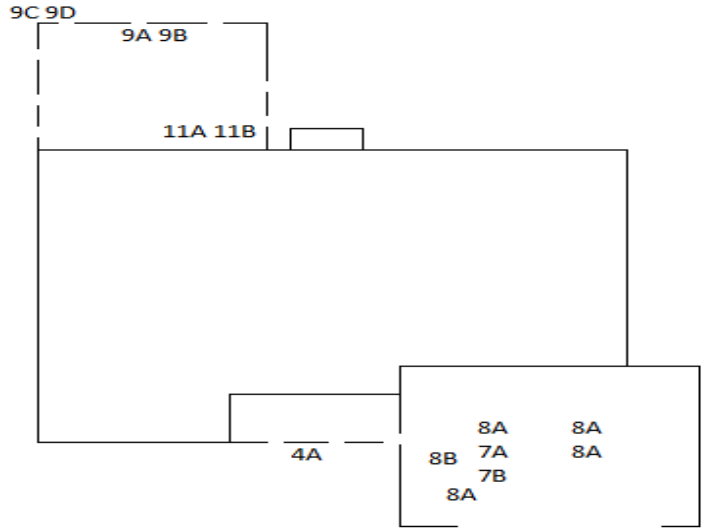
FOUNDATION DIAGRAM (Diagram not to scale)

Finding: 4A DRY ROT NOTED AT 6X6X8 POST AS INDICATED ON THE DIAGRAM.

Finding: 7B DRY ROT NOTED AT 2X2 PLYWOOD SHEATHING AS INDICATED ON THE DIAGRAM.

Finding: 8B DRY ROT NOTED AT 1/2 PRESSWOOD PLYWOOD SHEATHING AS INDICATED ON THE DIAGRAM.

Finding: 9A EVIDENCE OF DRYWOOD TERMITES NOTED AT BEAM AS INDICATED ON THE DIAGRAM.

Finding: 9B EVIDENCE OF DRYWOOD TERMITE DAMAGE NOTED AT 4X8X16 REGULAR BEAM AS INDICATED ON THE DIAGRAM.

Finding: 9C EVIDENCE OF DRYWOOD TERMITES NOTED AT JOIST AS INDICATED ON THE DIAGRAM.

Finding: 9D EVIDENCE OF DRYWOOD TERMITE DAMAGE NOTED AT 2X6X12 REGULAR JOIST AS INDICATED ON THE DIAGRAM.

Finding: 11A DRY ROT NOTED AT 1X8X4 SHEATHING AS INDICATED ON THE DIAGRAM.

Finding: 11B DRY ROT NOTED AT 2X4X2 REGULAR BLOCKS AS INDICATED ON THE DIAGRAM.

Finding: 7A WATER STAINS NOTED AT PLYWOOD SHEATHING AS INDICATED ON THE DIAGRAM

Finding: 8A WATER STAINS NOTED AT PLYWOOD SHEATHING AS INDICATED ON THE DIAGRAM

Recommendation: 4A **REPAIR AS NECESSARY TO CORRECT.**

Recommendation: 7B **REPAIR AS NECESSARY TO CORRECT.**

Recommendation: 8B **REPLACE AS NECESSARY TO CORRECT.**

Recommendation: 9A **DRILL AND CHEMICALLY TREAT LOCAL INFESTED TIMBERS WITH REG. CHEMICAL-. COVER EVIDENCE.**

Recommendation: 9B **REPLACE AS NECESSARY TO CORRECT.**

Recommendation: 9C **DRILL AND CHEMICALLY TREAT LOCAL INFESTED TIMBERS WITH REG. CHEMICAL-. COVER EVIDENCE.**

Recommendation: 9D **REPLACE AS NECESSARY TO CORRECT.**

Recommendation: 11A **REPLACE AS NECESSARY TO CORRECT.**

Recommendation: 11B **REPLACE AS NECESSARY TO CORRECT.**

Recommendation: 7A **OWNER TO CONTACT PROPER TRADESMEN TO MAKE ANY NECESSARY REPAIRS.**

Recommendation: 8A **OWNER TO CONTACT PROPER TRADESMEN TO MAKE ANY NECESSARY REPAIRS.**
